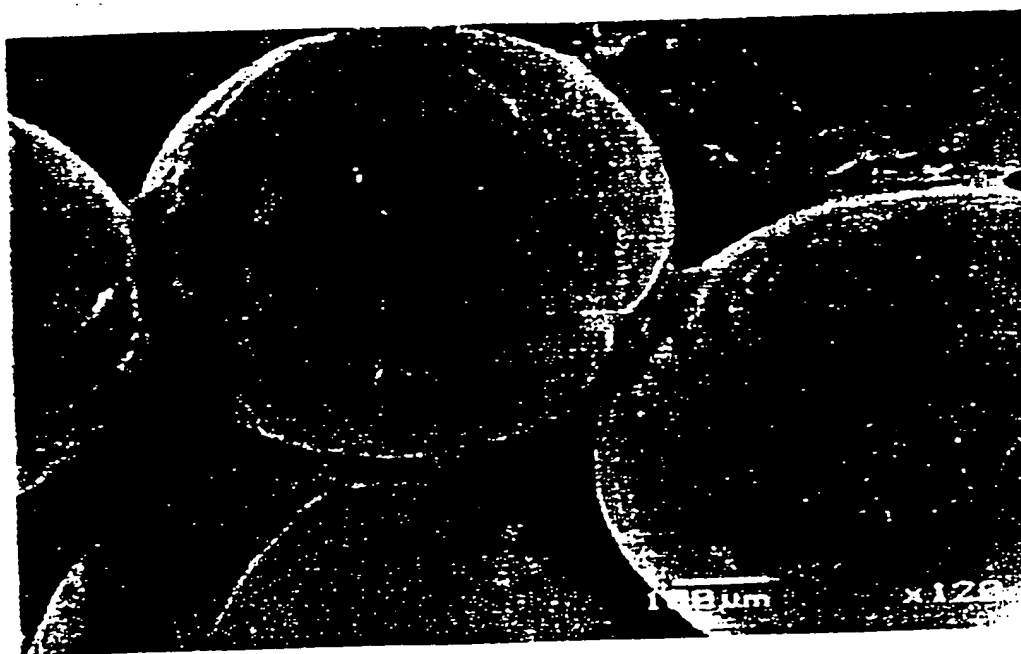
SEM micrographs of the Hayes CrCoMo sample after ASTM F746 corrosion test indicates intergranular corrosion attacks.
